ENGINEERING CHANGE ORDER

BOARD NAME <u>TORRENT CCD AFE BOARD</u>	ECO# TRNT-007	DATE <u>1/4/2010</u>
BRD SERL# <u>006 ></u>	ART# _____	
PN# _____ REV _____	REV _____	
ASBLY# <u>TRNT-EL-04-0004</u> REV <u>OD</u>	PCB# <u>TRNT-EL-04-1004</u>	REV <u>OD</u>
BOM# _____ REV _____	SCH# <u>TRNT-EL-04-2004</u>	REV <u>OD</u>
COGNIZANT ENGNR _____	APPROVD _____

REASON FOR MODIFICATION:
Get board functioning

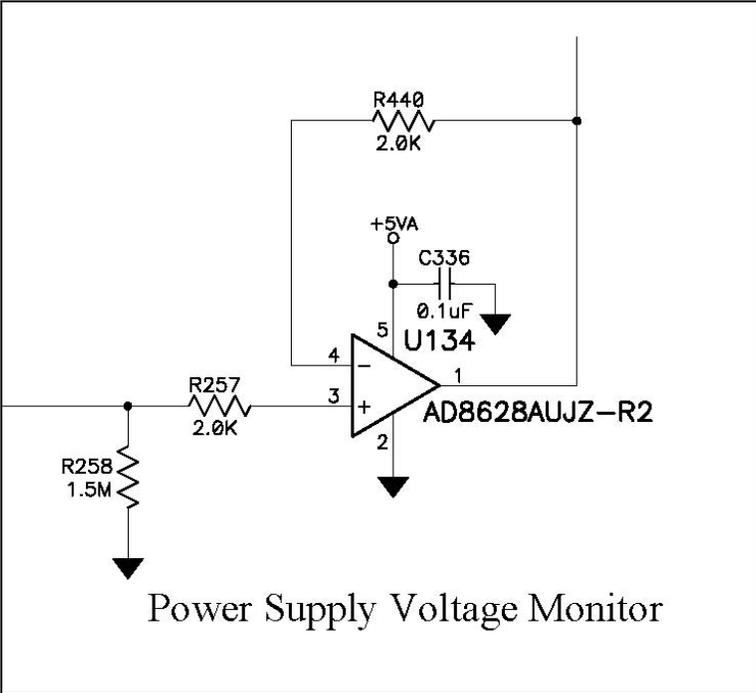
18	pcm 09/22/09	The disable (pin 7) of the ADA4941 devices (U75, U84, U93, U103) should be tied to -5V instead of GND.	
20	dgs 10/5/09	AFE_DATA_EN needs to be /AFE_DATA_EN	
21	pcm 10/07/09 TRNT meeting	U140 24AA128 eeprom Pin 7 (WP) should be tied to ground	
22	dgs 10/8/09	U145 should be wired as a voltage follower (copy of U134), i.e. gain=1, to preserve the 0-5V telemetry voltage range from the MUX to the ADC.	(use graphic on eco) see figure 1
23	dgs 10/30/09	/TELADC0_DOUT CHANGE TO TELADC0_DOUT	
24	dgs 11/2/09	The clock state switches (e.g. U28 for clock 0) are shown in the logic "1" state. Thus, the clock low state is wired to the logic high input. Should this be rewired for all clock channels? Currently this is corrected in firmware. Additionally logic state 0 should be VCLKLO signal, requires signals on pins 6 & 4 to be swapped.	change sch symbol to be drawn in the logic 0 state, additionally logic state 0 should be VCLKLO signal, requires signals on pins 6 & 4 to be swapped & rerouted.

Figure 1
Item 22 on action list
