## Bias Enable problem at Power on - Solution

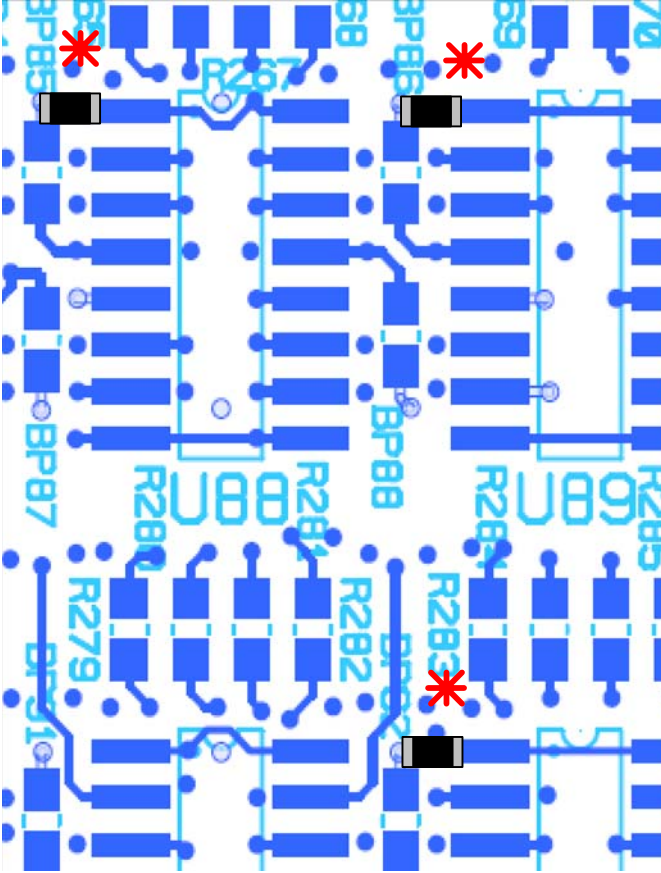
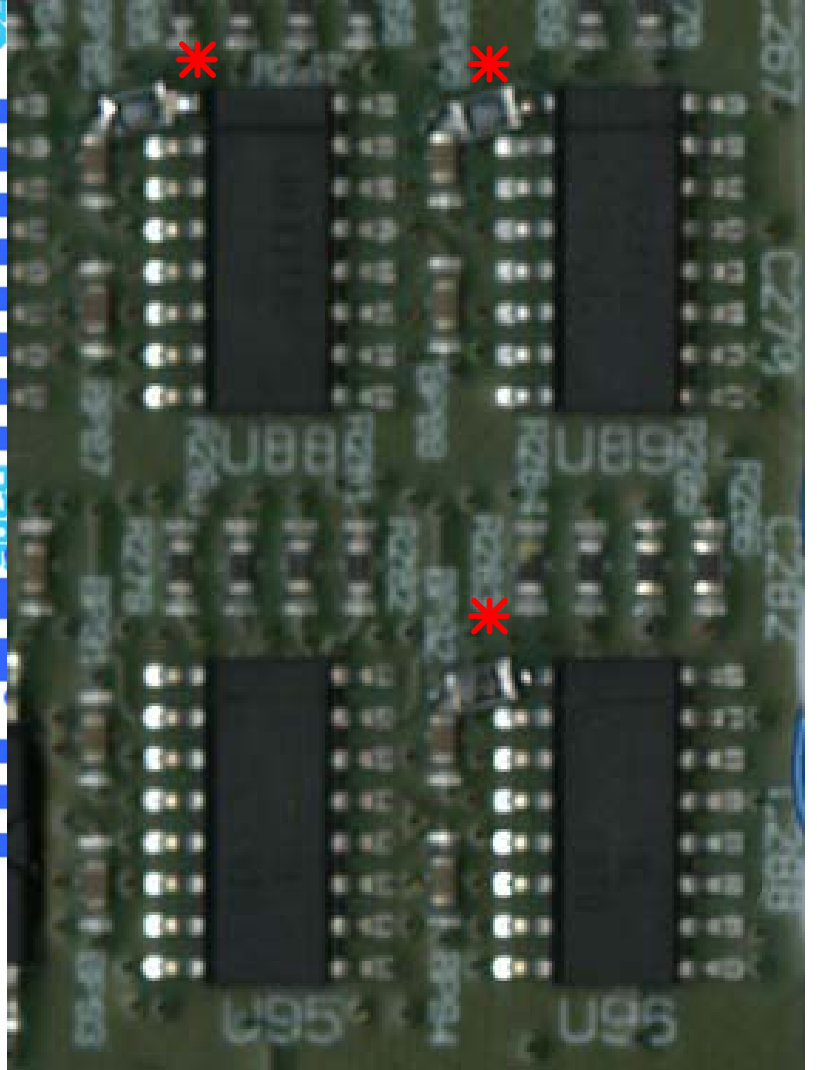
Resistors are pull downs to ground on from Pin 1 of U88, U89 and U96, which are the Bias Enable 0,1, 2 signals.

Add three 8.66k value 0805 size resistors to the locations shown below.

Remove resistor R315 from the top side of the board, R315 is located near the corner of the FPGA.
