# *The DECam System: Technical Characteristics*

Alistair R. Walker  
DECam Instrument Scientist

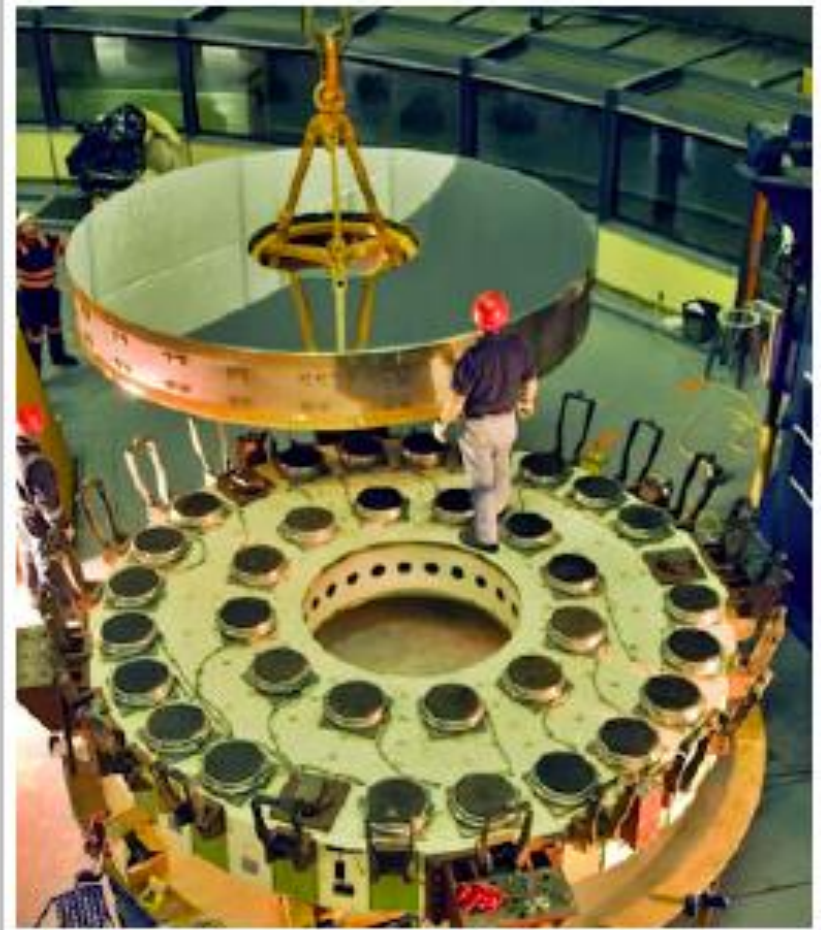
# Blanco-DECam Active Optics Systems

- Primary Mirror
  - 33 pressure transducers, provide forces to counteract gravity (proportional to cosine zenith-distance). The system resolution was recently improved with new hardware, factor 10 improvement in resolution.
  - Introduce a “baseline” astigmatism and trefoil (revised)
  - Plus corrections from a LUT (under test)
  - Plus tweaks (to be tested, maybe not needed? Update frequency?)
